Manhole Inspection Summary

Manhole # S19GG2016MH

Insp Date: **4/24/07 11:18 AM**

Location Address: **FALLS RD**

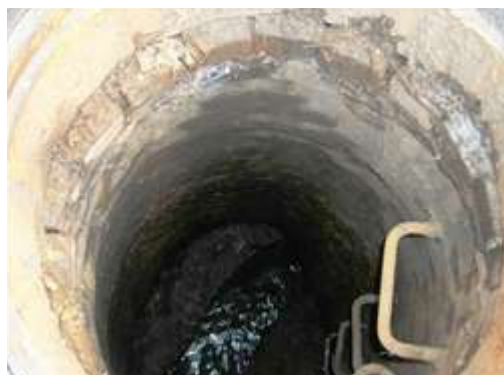
Defect

Frame leaks. Frame offset. Adjustment deterioration, loose brick and infiltration. Corbel and Barrel infiltration.
